# Cause Analysis for a Lining Damage in Sea Water System Piping Installed in a Korean Industrial Plant

K. M. Hwang<sup>1,†</sup> and S. K. Park<sup>2</sup>

<sup>1</sup>KEPCO E&C, 269 Hyeoksin-ro, Gimcheon-si, Gyeongsangbuk-do, 39660

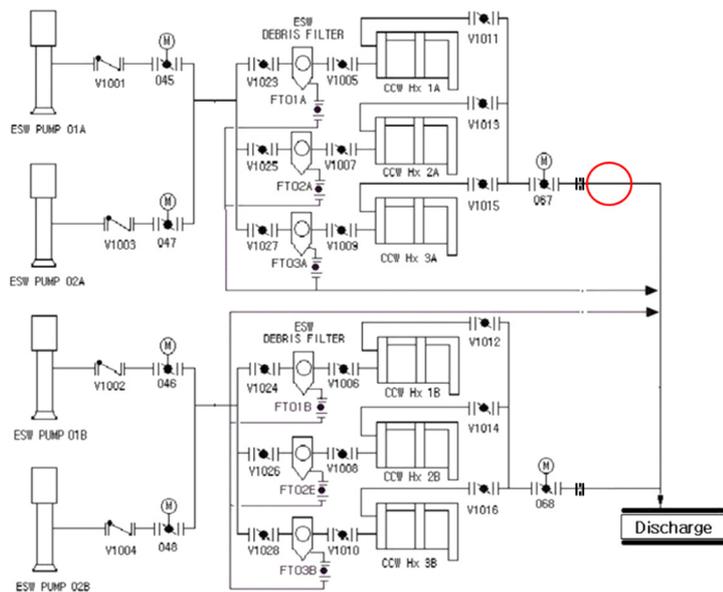
Fig. 2 System schematic diagram of the seawater system

tribution of void fractions in vertical sections of piping in contour and void fraction profile. It was assessed that cavitation occurred as it was assumed to be dissipated after air bubbles were generated near the pipe wall up to an area of approximately  $0.5D$  at the rear of the orifice. This corresponds to the pipe damage areas shown in Fig. 2 and Fig. 3.

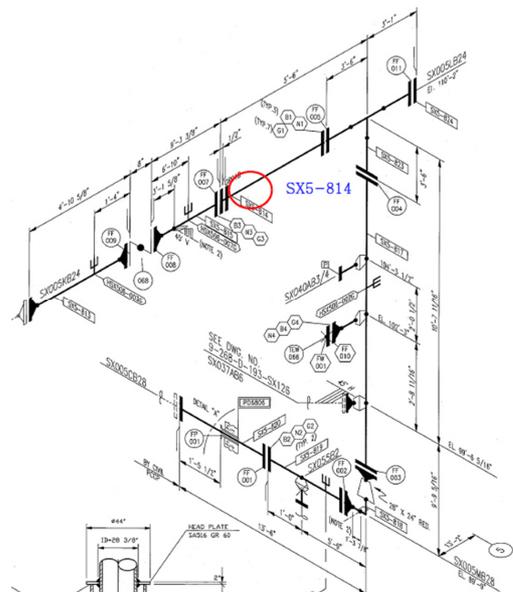
Fig. 3 Isometric drawing of the damaged pipe.

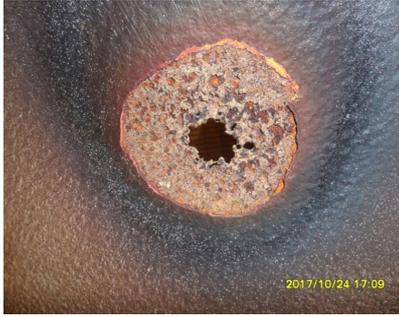
Fig. 4 Damaged inside surface.

the lining of the damaged pipe is peeled and the base metal is eroded, indicating that cavitation is the cause of the damage.

Visual inspection results show that the cause of the pipe damage in the component cooling seawater system is cavitation due to differential pressure at the front and rear of the orifice. As such, the cavitation evaluation was performed by engineering method. The cavitation evaluation was performed by the Tullis theory described in EPRI Report [4]. Cavitation and flashing are not evaluated as quantitative values, but rather as a method of evaluating the conditions under which the pipe is located by separating the occurrence conditions step by step. The intensity of the generation of the phasic cavitation can be calculated from the following equations (1) through (4) [5].

To prevent or mitigate such damage, it is necessary to find ways to prevent rapid pressure reduction by securing horizontal part length at the rear of the orifice, reducing cavitation through change of orifice hole size or type, and optimizing operation range with no cavitation.

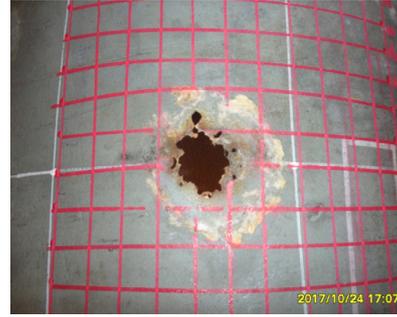
Fig. 5 Damaged outside surface.

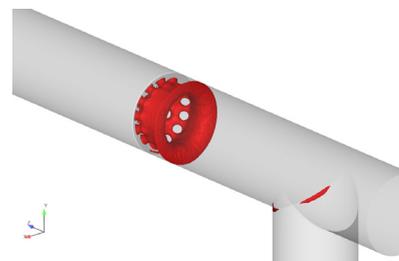
Fig. 8 shows the steam generation area derived from CFD analysis, and Fig. 9 and Fig. 10 illustrate the dis-

**Fig. 8 Steam generation area.**

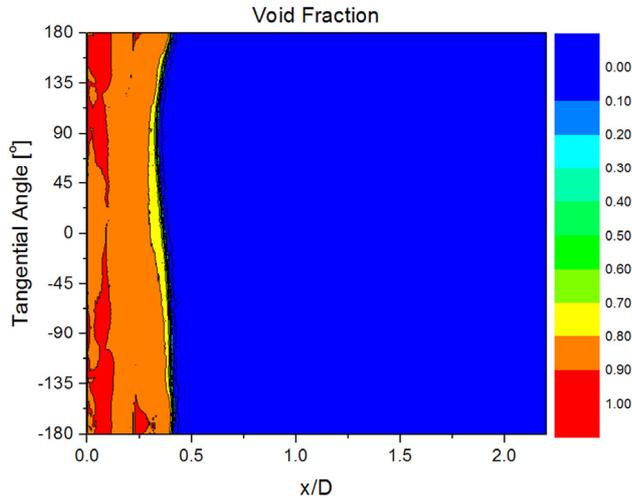
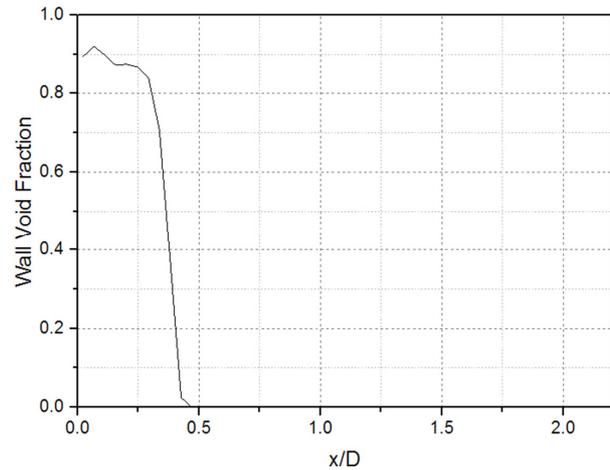
Fig. 9 Void fraction contour in vertical section

Fig. 10 Void fraction profile in vertical section
