# Factors Affecting Stress Corrosion Cracking Susceptibility of Alloy 600 MA Steam Generator Tubes

Kang Yong Seok<sup>†</sup>, Lee Kuk Hee, and Shin Dong Man

Korea Hydro & Nuclear Power Co., Ltd. CRI, Daejeon, Chungnam, 34101, Korea

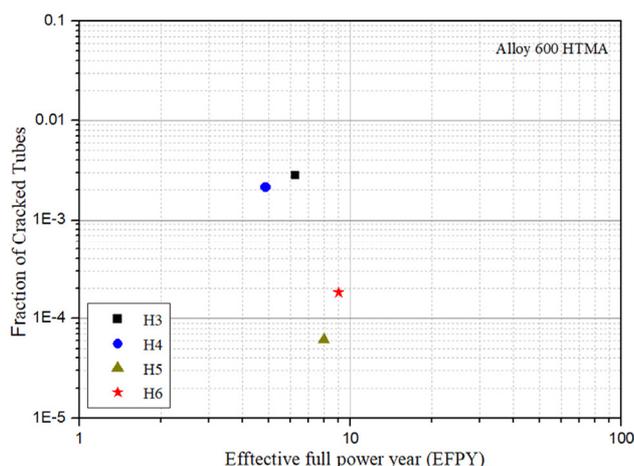
Fig. 1 Comparison of SCC Initiation Time.

Fig. 1 shows the comparison of the operating time until cracks are first detected in four units. The fastest case is 4.87 effective full power year (EFPY) at the H4 and the slowest case is 9.04 EFPY at H6. This means that the SCC incubation period of H6 is longer than that of previous plants with the same design.

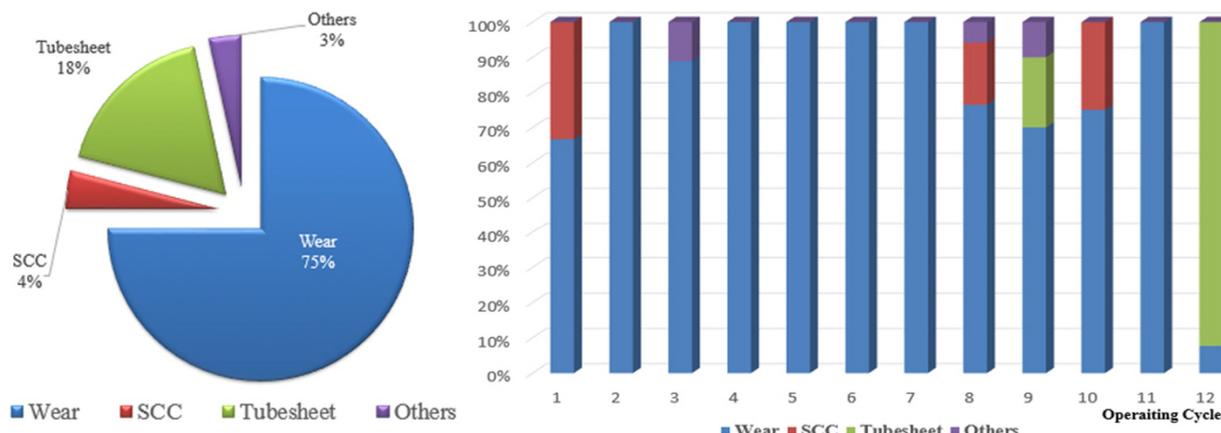
Fig. 2 Distribution of causes of tube plugging.

Fig. 2 shows the percentage of total numbers of tube failures caused by each degradation mechanisms for the first in-service inspection through the 12<sup>th</sup> in-service inspection of H6 SGs. Tube fretting wear and SCC were the main causes of the maintenance of the tubes. There was no cracks near the tube support plates. Compared with the state of preceding units, where the axial out diameter stress corrosion cracking (ODSCC) around the tube support plates was detected on a large scale, it is unusual that H6 was not detected at all until the end of the 12<sup>th</sup> cycles.

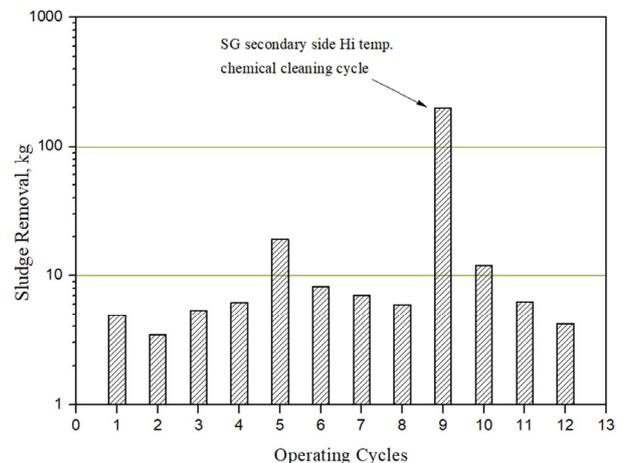
Fig. 3 History of sludge lancing at top of tube sheet.

Therefore, the sediment distribution and removal amount of sludge, which is an impurities on the secondary side of the steam generator, were analyzed. H6 has carried out sludge lancing at every refueling outage to remove the sludge deposited on top of tube sheet. Fig. 3 shows the amount of sludge removal from top of tube sheet of H6 SGs compared by operation cycles. Excluding the 9<sup>th</sup> operating cycle where chemical cleaning was applied, the average amount of sludge removal per cycle is less than about 10 kg, which is very small compared to the preceding plants. Also, measurement of iron ingress through the feed water and the thickness of sludge profile as measured

by analyzing the eddy current inspection signal also consistently indicated there is less sludge deposit in H6 than H3 & H4.

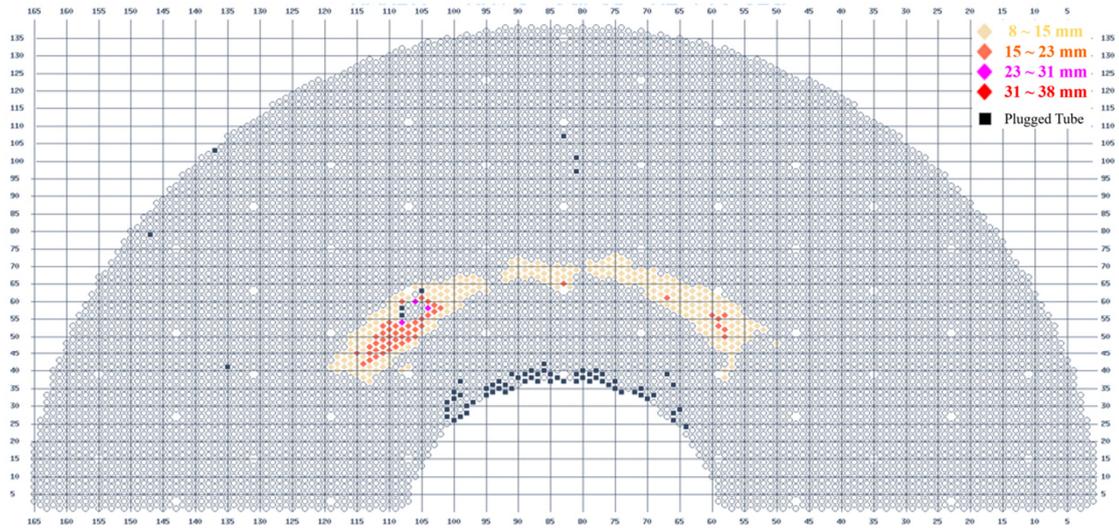
Fig. 4 Distribution of sludge pile on top of tube sheet.

Fig. 4 shows the distribution profile of sludge on top of tube sheet of H6 SGs at the 12<sup>th</sup> in-service inspection. It is only limitedly deposited in the heavy sludge deposition region, and the deposition height is mostly low. From this, it is judged that limited transport of impurities into the H6 SGs was properly controlled.

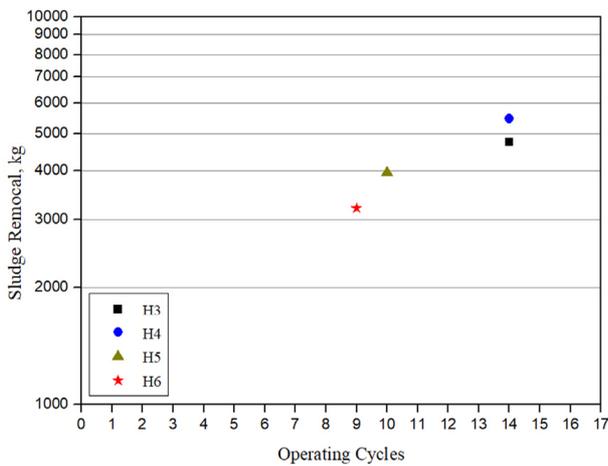
Fig. 5 Comparison of sludge removal by chemical cleaning.

For all units, the same high-temperature full-bundle chemical cleaning process was applied to alleviate ODSCC. In Fig. 5, which compares the amount of sludge removed by chemical cleaning in four units, the amount of H6 removed is the least. It can be seen that the corrosive environment is the mildest because the amount of sludge of H6 is small. Also noteworthy here is that the timing of application of chemical cleaning of H6 was earlier than that of other units. As can be seen from Fig. 5, chemical cleaning in H6 was applied at the 9<sup>th</sup> in-service inspection (10.4 EFPY), but other units were applied later than this. In other words, it is estimated that because chemical cleaning was applied earlier than other units, the corrosive environment of tubes was relatively improved, resulting in a longer crack incubation period and a slower growth rate.
