## Failure Investigation of Fire-Side Water-Wall Tube Boiler

M. C. Fatah<sup>1,†</sup>, D. Agustiadi<sup>1</sup>, and A. W. Pramono<sup>1,2</sup>

Unforeseen failures of boilers in power plants may affect the continuation of electricity generation. Main failures in boilers are influenced by the tube material, tube position, boiler service temperature and pressure, and chemical composition of the feed water and coal. This investigation was intended to find answers on the causes and mechanism of failure of the fire-side boiler water-wall tubes, due to perforation and corrosion. The tube conformed to the material requirements in terms of its chemical composition and hardness. Microscopic examination showed ferrite and pearlite indicating no changes in its microstructure due to the temperature variation. SEM test showed a single layer and homogenous film density particularly on the area far from perforation. However, layers of corrosion product were formed on the nearby perforation area. EDX showed that there were Na, Ca, S, and O elements on the failed surface. XRD indicated the presence of Fe<sub>2</sub>O<sub>3</sub> oxide. The failure mechanism was identified as a result of signifi

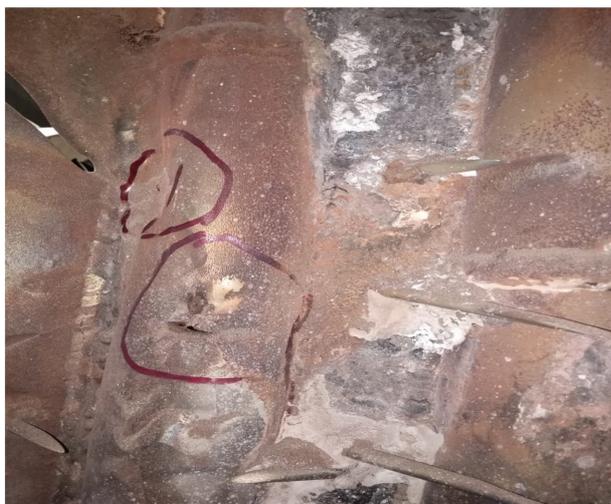
Fig. 1. Photograph of failed tube inside the boiler

The failed water-wall tube is shown in Figs. 1 and 2. It is clearly seen that there were two perforations on the tube (A and B locations) with the approximate dimension (length × width) of 3 mm × 2mm and 10 mm × 2 mm, respectively. Thickness measurements showed significantly reduction in thickness from 6 mm to approximately 1.5 mm for A and 3 mm for B location. In addition, the

failed surface of the tubing was covered with red-brown colour indicating iron oxide scale.

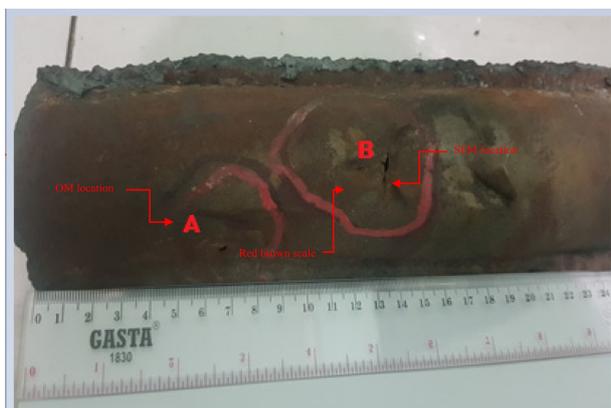
Fig. 2. Photograph of the failed tube after removed from inside boiler.

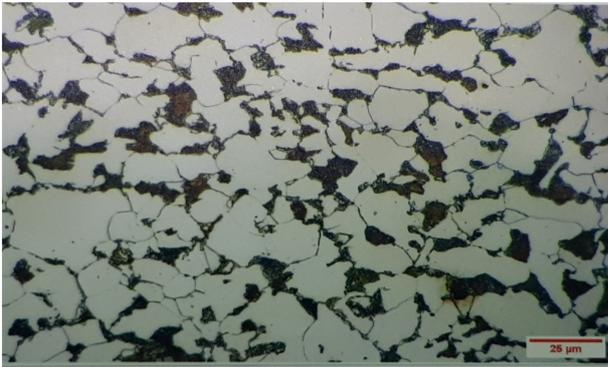
Fig. 3. Optical metallograph of the failed tube

The optical micrograph prepared from fractured water-wall tube is shown in Fig. 3. The general microstructure consisted of ferrite and pearlite grain structure indicating no obvious microstructural degradation due to localized temperature variation during service.

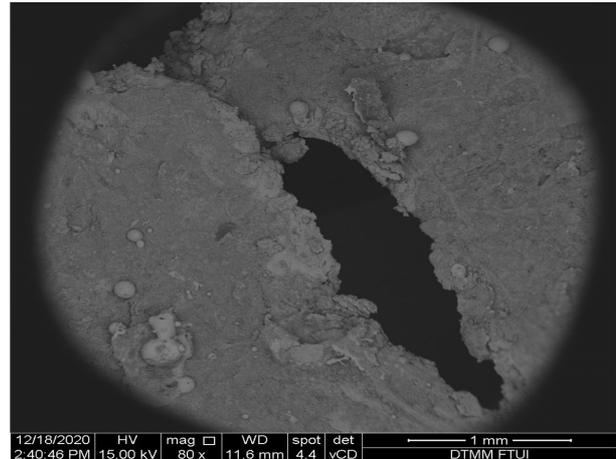
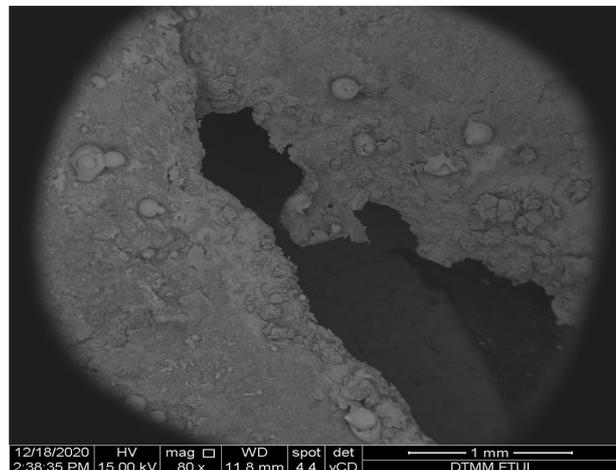
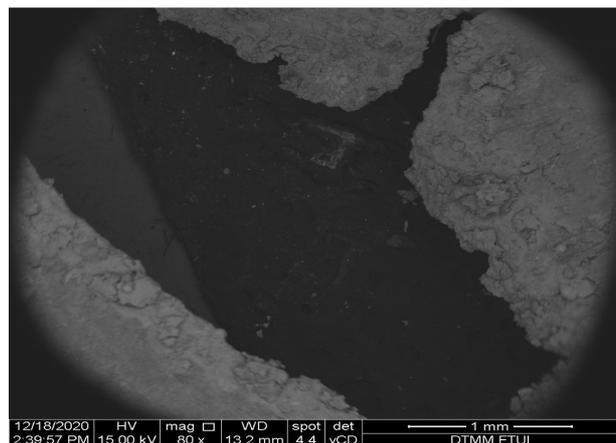
The results of SEM micrograph are shown in Fig. 4. It is obviously seen layers of corrosion product was formed particularly on the nearby perforation area. EDAX (Figs. 5 and 6) confirmed the presence of Na, Ca, O and S elements on the corrosion product. It is believed that the presence of Na, Ca, and S comes from the fossil fuels [5].

Fig. 4. Various SEM images of failed tube

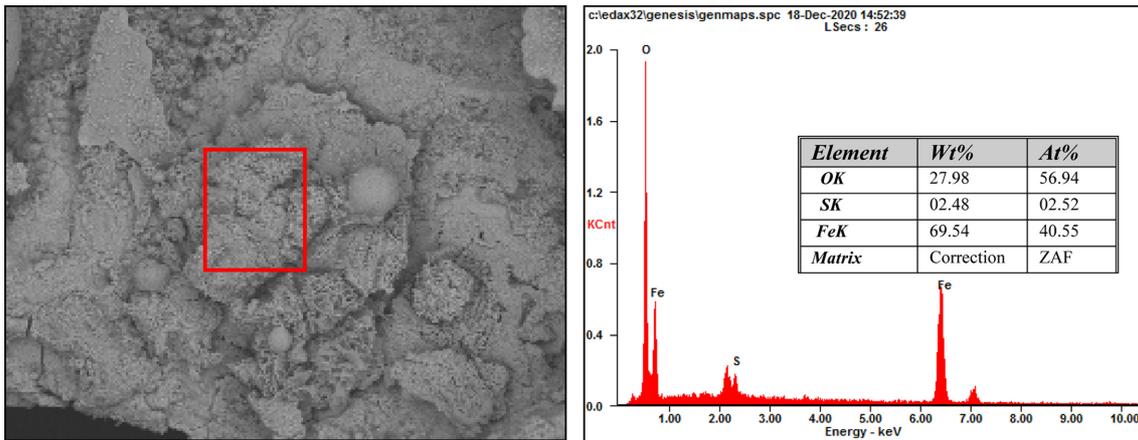
not detected by XRD results. However, EDAX results confirmed the presence of Na, S and O elements that might indicate the presence of  $Na_2SO_4$ .

Fig. 5. SEM and EDX analysis of the failed tube at location A

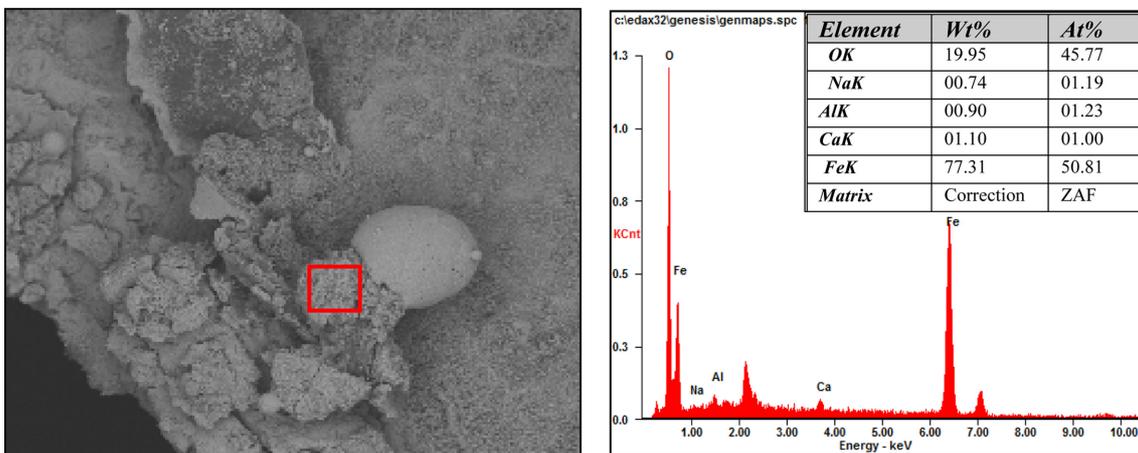
Fig. 6. SEM dan EDX analysis of the failed tube at location B

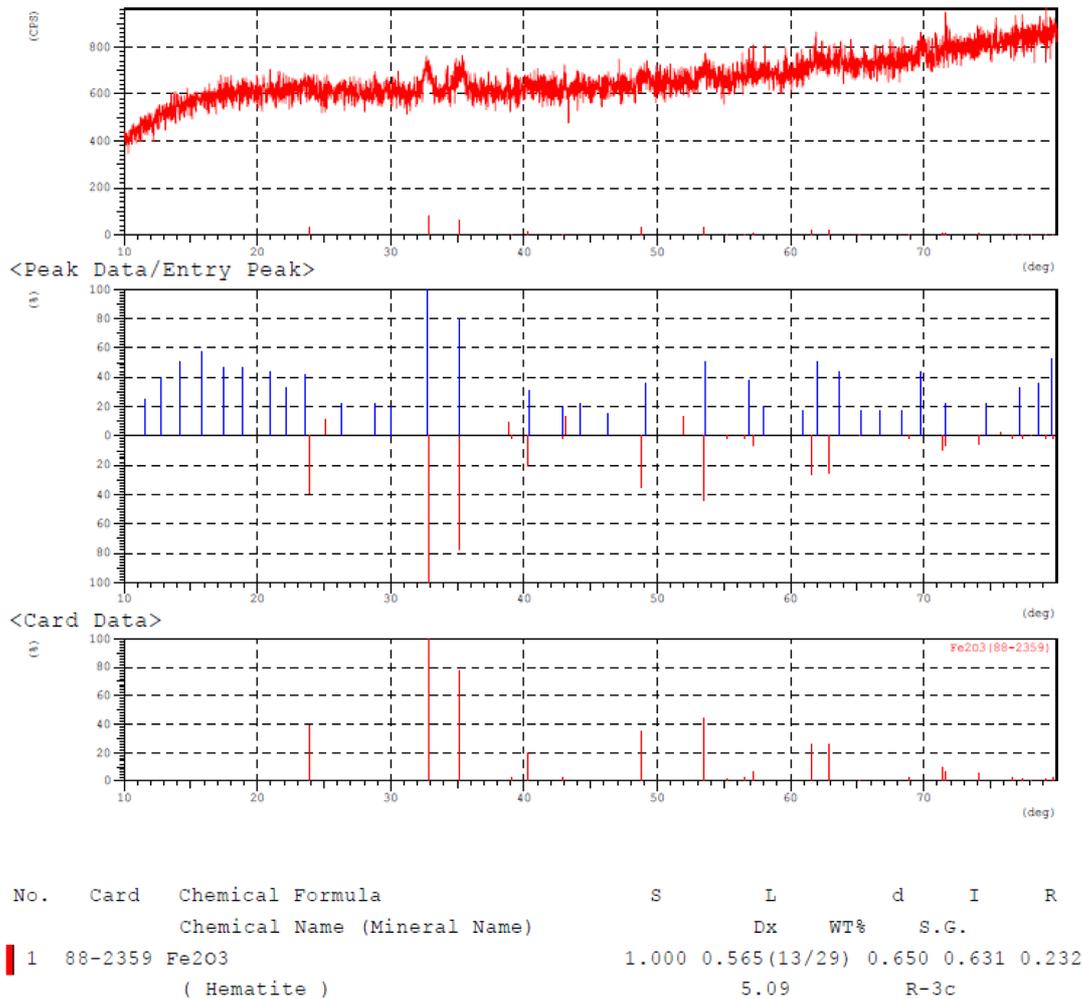
The result of XRD is shown in Fig. 7. It is confirmed the presence of  $Fe_2O_3$  (hematite) film on the failed tube surface.

Fig. 7. XRD results of film formed on the failed tube

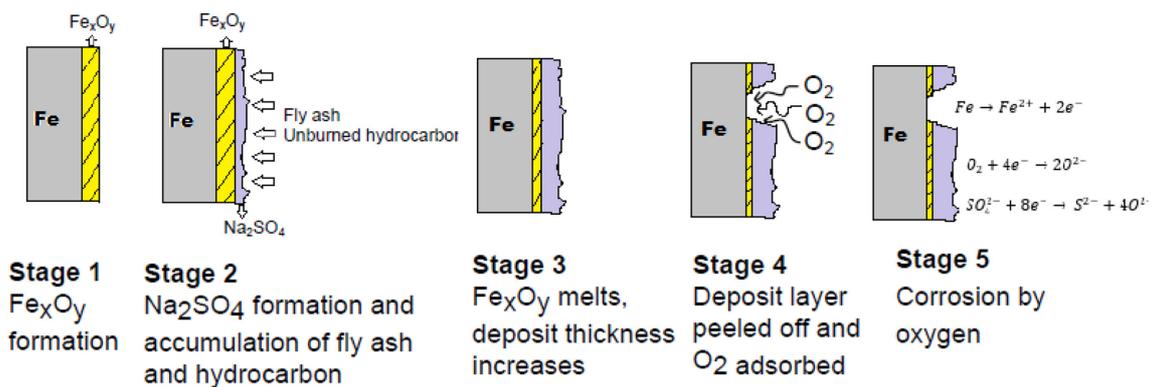
At the initial stages of boiler condition, an oxide film was formed on the external tube surface due to reaction of the steel with oxygen. Sodium sulphate then deposited on the oxide layer. Afterward, the outer surface of  $\text{Na}_2\text{SO}_4$  layer began to become sticky and adsorbed fly ash particles dissolving the oxide layer of metal and increasing the deposit thickness [7]. By increasing deposit thickness, the temperature gradient also increased gradually. High temperature ( $\pm 600^\circ\text{C}$ ) caused the deposits and oxide layers vanished from the surface and hence further oxidation of the metal occurred [7,8]. Oxidation corrosion of steels was easy to happen due to high affinity of oxygen to react with steel to form oxides. The kinetic of oxidation was higher at high temperatures than room temperature [9]. The simple schematic diagram of boiler fire side tube corrosion could be seen in Fig. 8.

Fig. 8. The schematic diagram of fire side wall tube corrosion
