## Failure Analysis of Stress Reliever in Heat-Transport Pipe of District Heating System

The objective of the present study was to perform failure analysis of double-layered bellow (expansion joint), a core part of stress reliever, used to relieve axial stresses induced by thermal expansion of heat-transport pipes in a district heating system. The bellow underwent tensile or compressive stresses due to its structure in terms of position. A leaked position suffered a fatigue with a tensile component for decades. A cracked bellow contained a higher fraction of martensitic phase because of manufacturing and usage histories, which induced more brittleness on the component. Inclusions in the inner layer of the bellow acted as a site of stress concentration, from which cracks initiated and then propagated along the hoop direction from the inner surface of the inner layer under fatigue loading conditions. As the crack reached critical thickness, the crack propagated to the outer surface at a higher rate, resulting in leakage of the stress reliever.

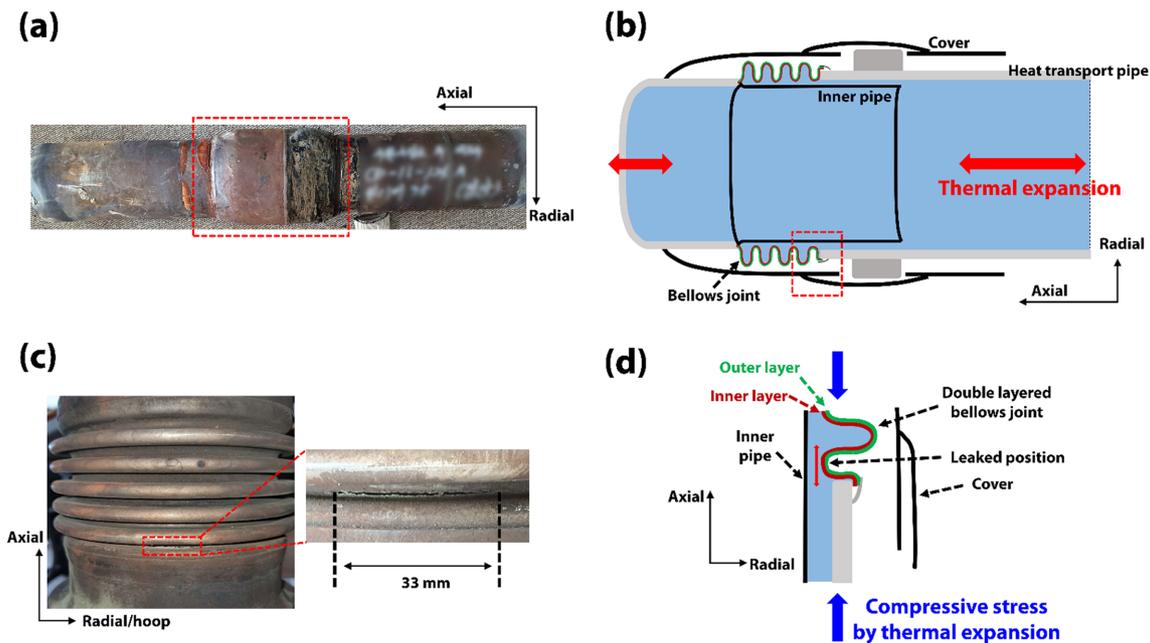
**Fig. 1.** (a) Leaked stress reliever installed with heat-transport pipes, (b) schematics of a cross-section of stress-reliever indicated by the red dash-line box shown in (a), (c) images of cracked bellows joint and its crack, (d) schematics of bellows joint indicated by the red dash-line box shown in (b).

The present study deals with leakage of stress reliever for relieving the stress of pipes induced by thermal expansion in heat-transport infrastructure. The stress reliever indicated by the red box in Fig. 1a is located between heat transport pipes of 125 mm in diameter. It is exposed to corrosive environments such as 0 ~ 120 °C and 16 bar of pressure from hot water, which induces thermal expansion and/or contraction of pipes. During operation, these axial stresses of pipes are relieved by shrinking or stretching the bellows joint (Fig. 1b). It is usually installed and used at specific distances. In this study, the leakage test was performed on the pipes assembled with the stress reliever, and the leakage between heat-transport pipes and the cover was observed (Fig. 1a) by disassembling it. A crack of 33 mm length along the hoop direction on the lower part of the bellows joint was found, and heat transport water was leaked through it (Fig. 1c).

A thermal gradient of heat-transport pipes induced by the flow of hot water made the pipes be axially extended (Fig. 1b), which imposed compressive stresses on the bellows joints (Fig. 1d). Due to the structure of the bellows joint, it should induce axial tensile stress on the inner surface which is a leakage position and weak axial tensile or compressive stresses on the outer surface. Thus, stress relievers with heat-transport pipes experienced the repetitive

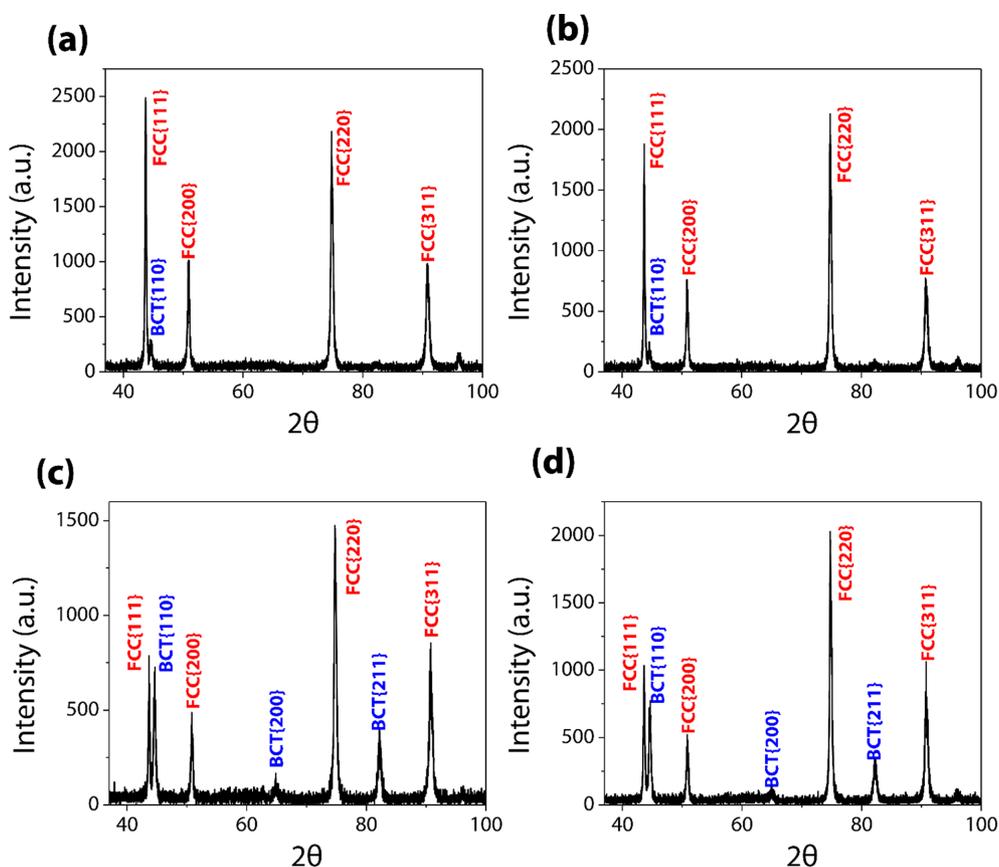
**Fig. 2. X-ray diffraction spectra for (a) inner and (b) outer layers of crack-free bellows joint, and (c) inner and (d) outer layers of cracked bellows joint**

their chemical composition and phase constituents were compared to unravel the difference between both bellows joints. The chemical composition of the crack-free and cracked bellows joints measured by ICP-AES was presented in Table 2. While the chemical composition of outer and inner layers in both bellows joints was almost similar, a slight difference between crack-free and cracked bellows joints was observed. It is not directly related to cracking, but it can be speculated that the manufacturing history of each bellows joint was different. Fig. 2 shows XRD results of the crack-free and cracked bellows joints, which revealed that both components contained a face-centered cubic (FCC) austenitic phase for the matrix and body-centered tetragonal (BCT) martensitic phase. Phase constituents were obtained by Rietveld refinement on diffraction spectra, which exhibited that the contents of martensitic phase in the inner and outer layers of the crack-free bellows joint were 5.6% and 4.2%, and those of the cracked counterpart were 31.3% and 30.4%, respectively. The higher fraction of the martensitic phase in the cracked bellows joint induces more brittleness in the component, which can assist initiation and propagation of cracking.

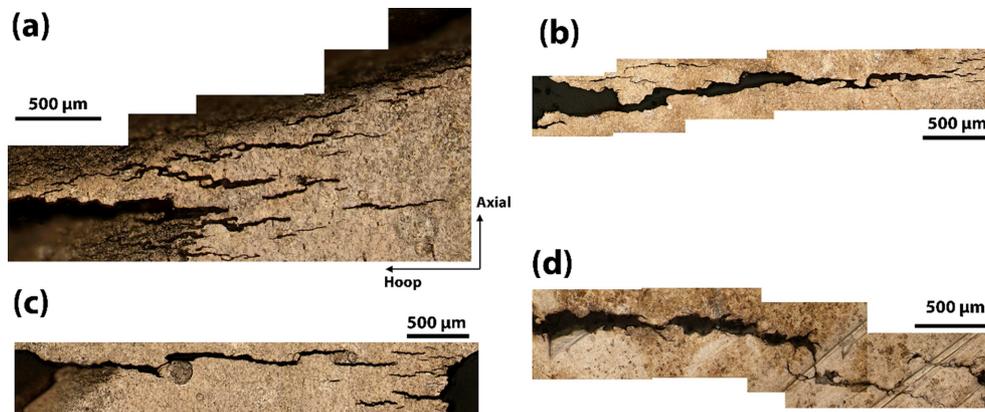
Cracking behavior reflects on the causes and history of failure. Fig. 3 shows the secondary cracks of inner and outer layers near the tip of the main crack. It can be observed that numerous secondary cracks were found along the hoop direction on the inner surface of the inner layer (Fig. 3a), while a relatively lower number of secondary cracks was discovered on the outer surface of the inner layer (Fig. 3b). Similar trends were observed in the outer layer, where more secondary cracks were revealed on the inner surface than on the outer surface in the outer layer (Figs. 3c, 3d). These indicate that the cracks were initiated from the inner surface of both double layers in the bellows joint.

**Fig. 3. OM images of the secondary cracks near the main crack and its tip on (a) inner and (b) outer surfaces of the inner layer, and (c) inner and (d) outer surfaces of the outer layer**

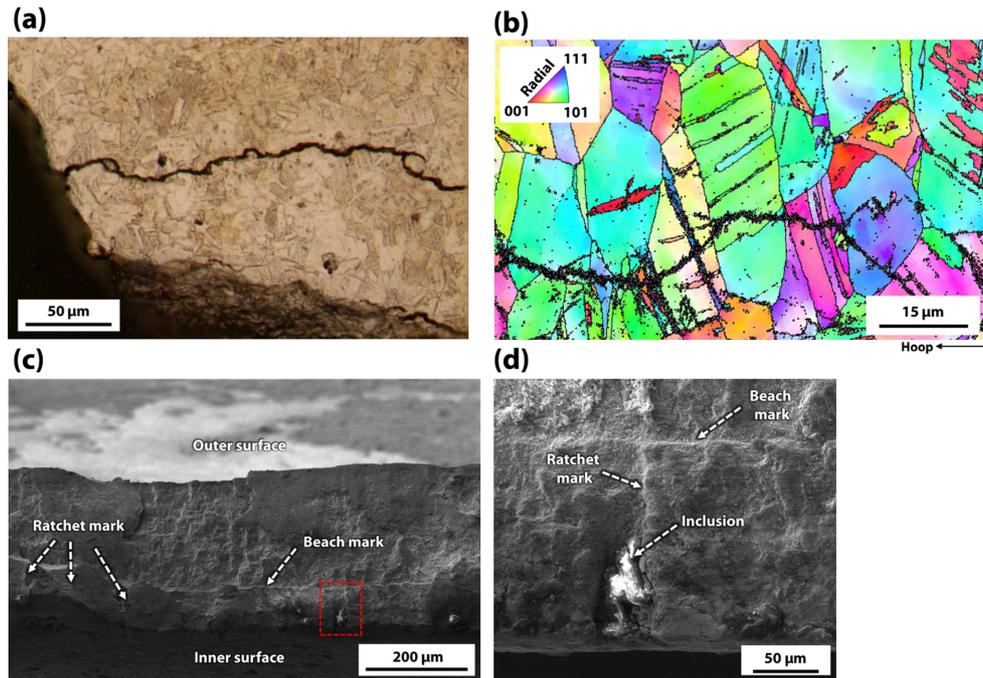
Figs. 4a and 4b present that the secondary cracks in the inner surface of the inner layer propagated with a transgranular mode, which exhibits the brittle fracture behavior of the austenitic matrix [9]. The history of the cracking behavior is inferred from the morphology of the fracture surfaces. A distinct beach mark lay on the fracture surface close to the inner surface (Fig. 4c), which indicates that through-thickness-direction cracking behavior was changed during crack propagation. In particular, several ratchet marks on the inner surface side of the fracture

Fig. 4. (a) OM image, (b) inverse pole figure map showing the propagation of the secondary crack on the inner surface of the inner layer, (c) fracture surface of the inner layer, and (d) magnified area of red-dashed line box shown in (c)

surface indicate that crack initiation points were located on the inner surface side of the layer. A magnified Fig. 4d shows the inclusion, ratchet mark, and beach marks. The chemical composition of the inclusions is presented in Table 3. It is difficult to define it precisely, but it might be the oxide which has been generated or not removed during the manufacturing process [10]. Since it was embedded near the inner surface of the inner layer, external load by thermal fatigue should be concentrated in the vicinity of these inclusions.

It is thought that the crack was initiated from the inclusion, as shown in Figs. 4c and 4d, because the inclusion is a site as a stress concentration under the fatigue during operation. The cracks initiated from the vicinity of the inclusion left a ratchet mark as a result of crack propagation on the fracture surface (Fig. 4d), and other onsets of cracks also created ratchet marks on their sites (Fig. 4c). The beach mark close to the inner surface of the fracture surface indicates that the crack propagation rate was different between the upside and downside of the beach mark. In other words, the crack was initiated from the inner surface of the inner layer, and it was propagated along the hoop and through-thickness directions until the tip of the cracks reached a beach mark. Then, the crack propagation reached a critical thickness (beach mark thickness), in which the bellows joint could no longer withstand, thus the crack propagated to the outer surface at a higher speed.

For countermeasures and preventive measures, the process to verify the identical or uniform quality of the bellow joint and its material is required. Since it experiences continuous fatigue, the materials exhibiting stable TRIP performance are recommended. Inclusions in stainless steel should be avoidable and managed.
