# Cause Analysis for a Lining Damage in Sea Water System Piping Installed in a Korean Industrial Plant

K. M. Hwang<sup>1,†</sup> and S. K. Park<sup>2</sup>

<sup>1</sup>KEPCO E&C, 269 Hyeoksin-ro, Gimcheon-si, Gyeongsangbuk-do, 39660

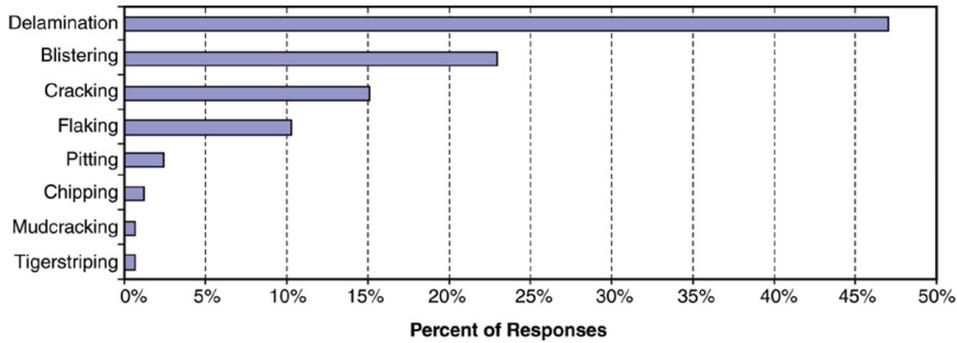
Fig. 1 EPRI survey results for lining damage.

According to a 2006 U.S. EPRI survey on the causes of lining damage [3], it was found that lining damage by delamination was the most common, followed by blistering, cracking, flaking, etc. Fig. 1 shows the EPRI survey results for lining damage.

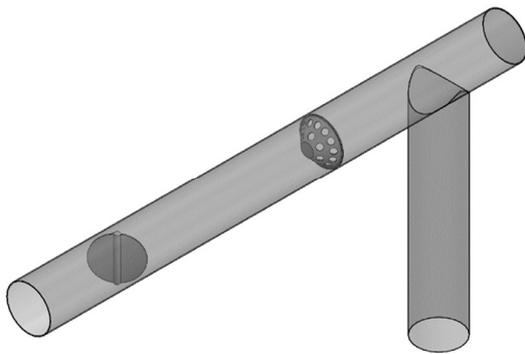
Fluid dynamic analysis was conducted to analyse the possibility of cavitation using the ANSYS FLUENT code. The analytical model ranges from the pipe in front of the valve 068 shown in Fig. 3 to the vertical pipe TEW 066 lower 30.34 m (99.526 ft) (elevation). Fig. 6 shows the target model, and Fig. 7 shows the grid system. The composite grid was used. The butterfly valve, orifice, and tee areas with relatively complex features were based on the tetrahedral grid. The rest of the area was based on the prism grid using the sweep mesh technique. The boundary conditions for analysis are same as shown in Table 1.

**Fig. 6 Target model.**

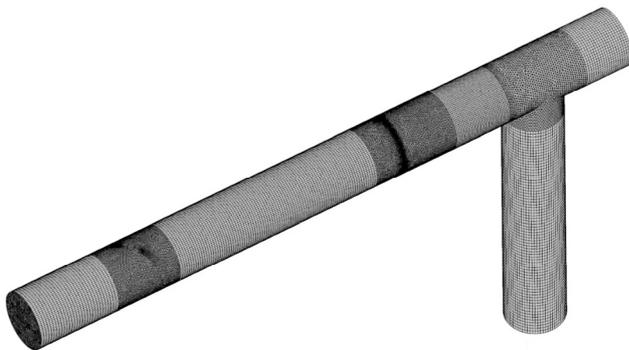
**Fig. 7 Grid composition.**
